# Marcilio Dias D25

USS Henry W. Tucker DD/R 875

# Background

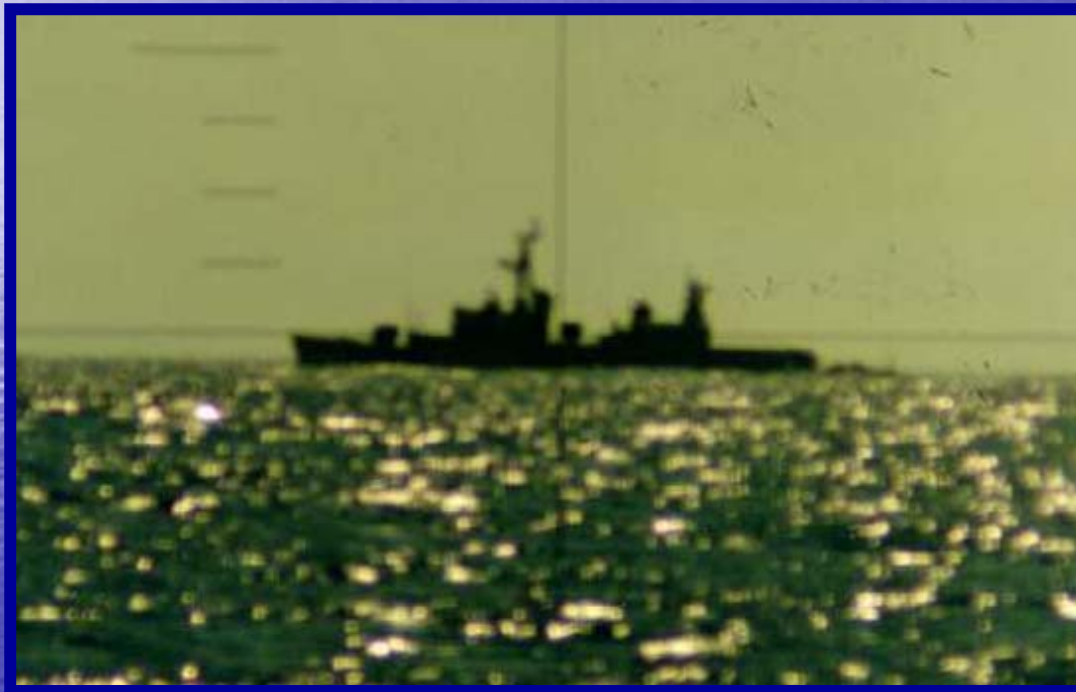
# From Tamoio's Periscope

Her hull was prepared for the exercise: the fuel tanks were cleaned and gas free to avoid secondary explosions, and some water tight doors and hatches were left open to force a trimmed sinking.

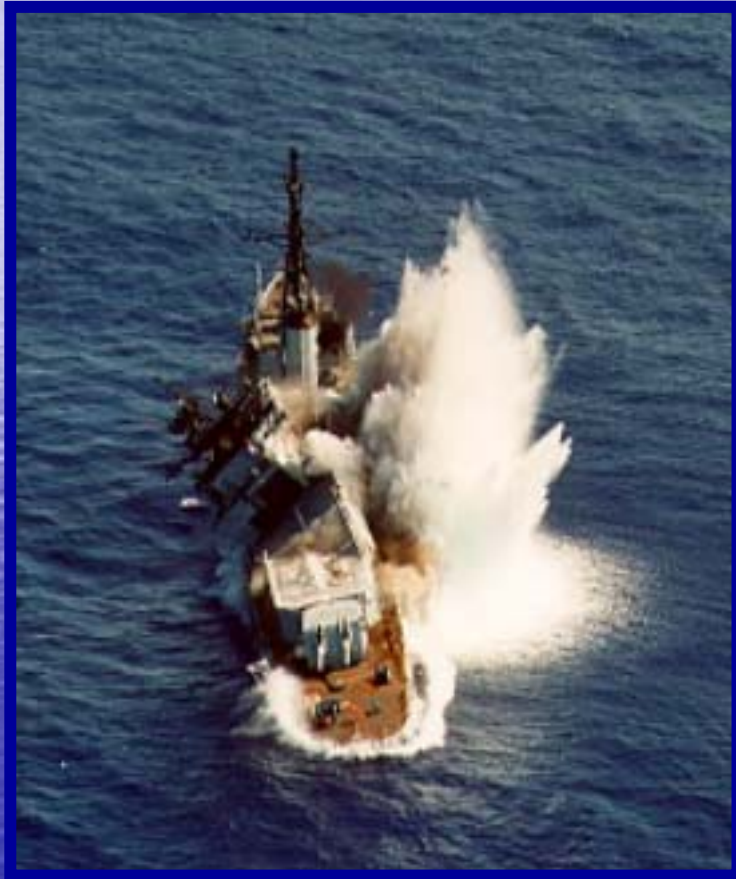
# Shockwave

You can see in this photo that the ship's superstructure was violently displaced abeam due to the explosion below the keel. An extremely high pressure shock wave and a huge gas bubble (from explosive products) were generated and begun to load the hull, causing HWT to bend and hull to fracture right above loading point (near bulkhead between B-3 and B-4). Smoke came out the stack suggesting that our fellow BTs were attempting to light up the ship and make her escape from that dramatic fate... but it was just soot coming out because the sudden acceleration of the shock wave.

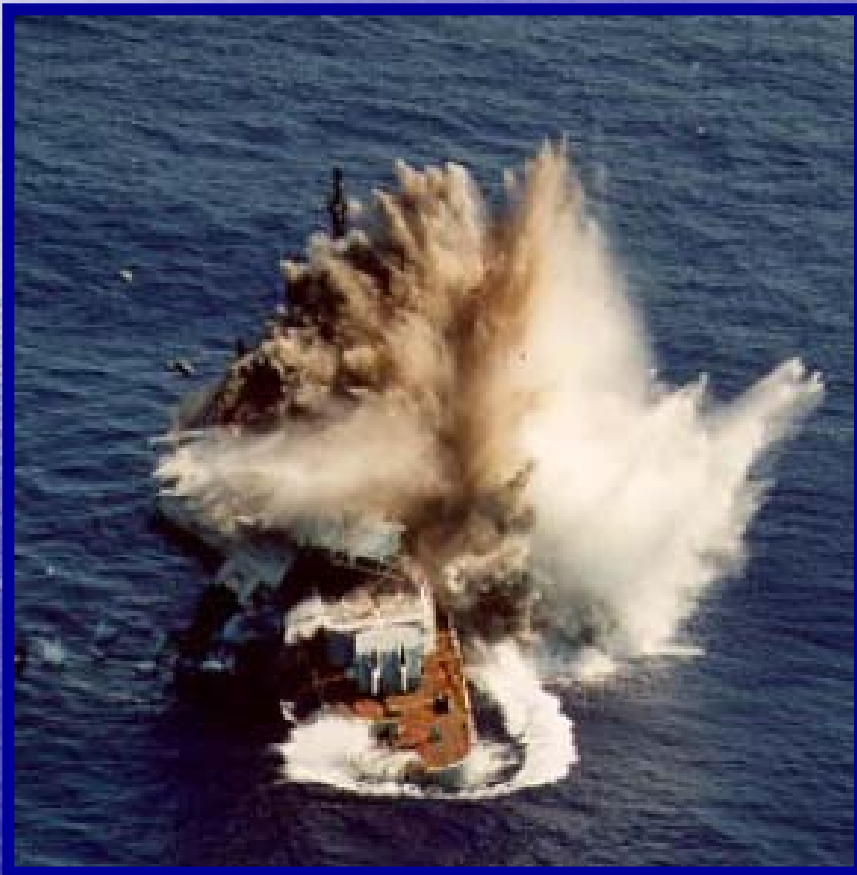
# Shockwave

As HWT bent upward, shock loading suddenly ceased, but expanding gas bubble kept the load on the hull, causing it to fracture more. After some milliseconds, the gas bubble shrunk and caused the hull to sag in a whipping movement. Further fracture occurred as a water jet passed through the ship.

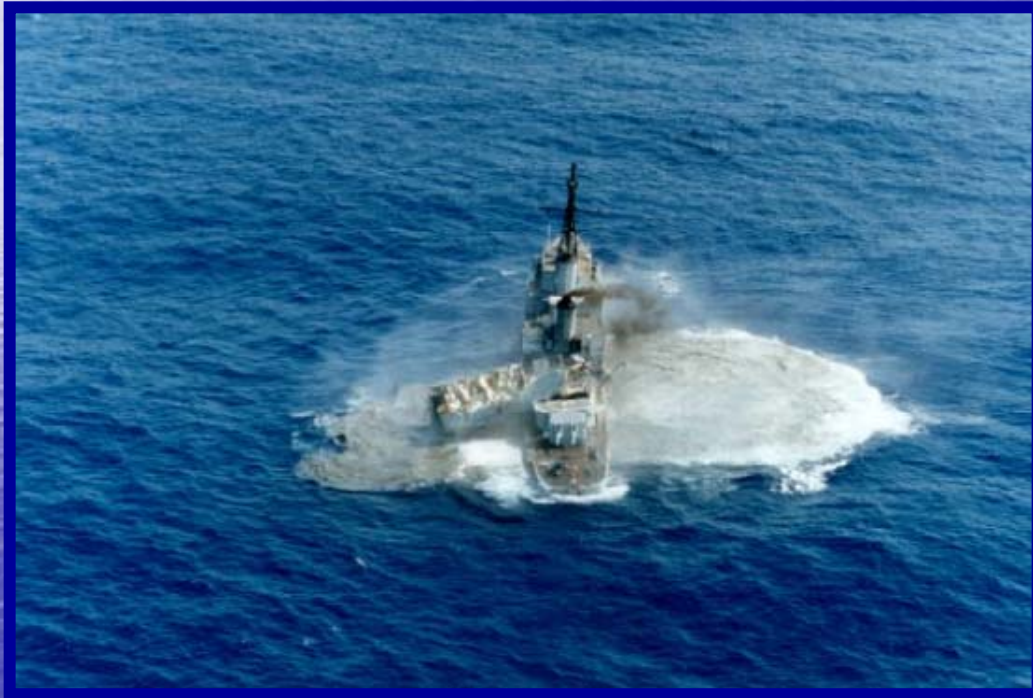
# Displaced Superstructure

There was a second expansion of the gas bubble and it also vented through the hull. This caused the removal of the superstructure, completely breaking the ship in two parts.
